Enhancing water security in Southern Africa by tackling nitrate contamination of aquifers and unraveling links to climate change and sanitation: A case from Ramotswa, Botswana

Bonnie McGill and Karen G. Villholth

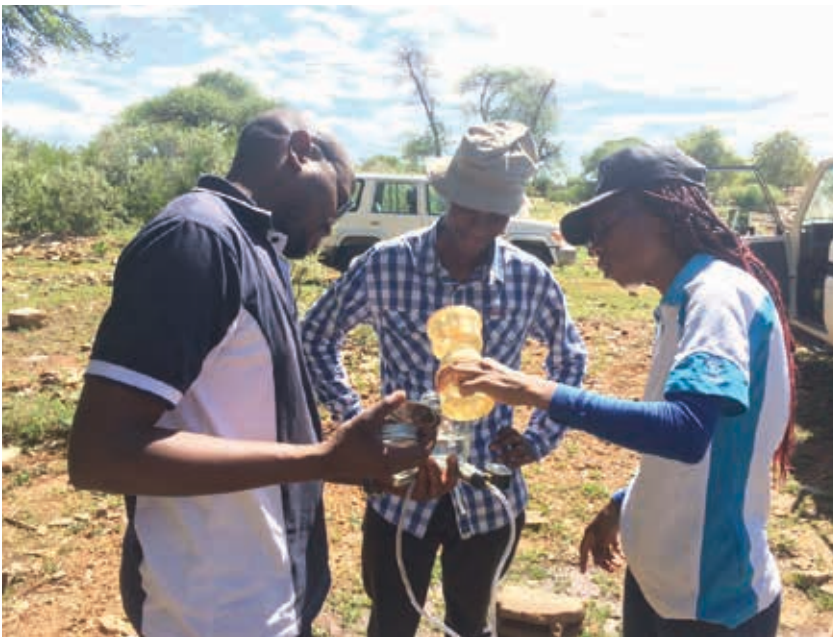
Pheмо Moleje (Botswana Geoscience Institute), Pheмelo Makoba (Department of Water Affairs) and Kgabi Gaboutloeloe (University of Botswana) filtering a groundwater sample in January 2017 (photo: Bonnie McGill).

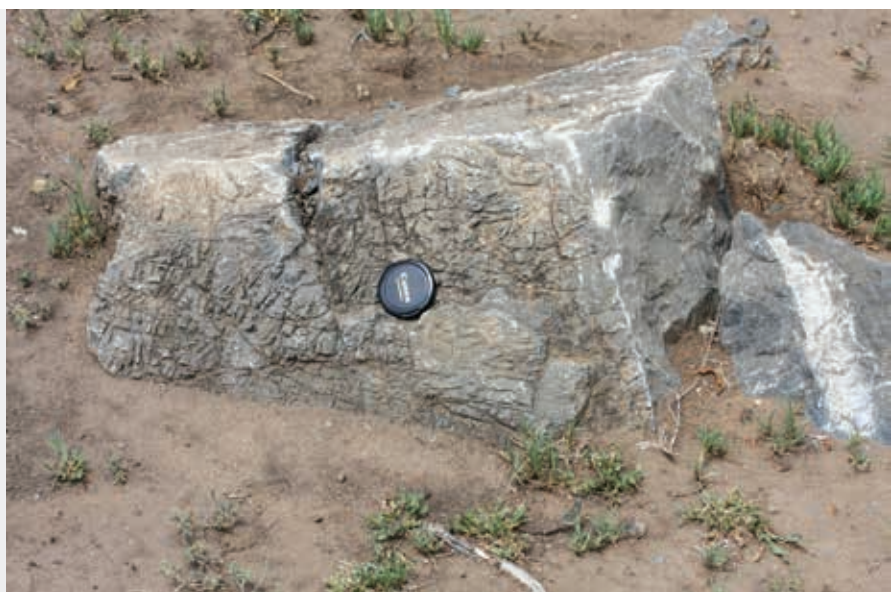
FIGURE 2. Outcrop of dolomite rock in Ramotswa (with lens cap for scale). The “elephant skin” texture is the result of weathering away of the rock. The same process creates channels below the surface allowing recharge water (or leaking pit latrines) to quickly infiltrate the aquifer.

Ramotswa (Figure 1) is a town located on an outcrop of the transboundary Ramotswa aquifer (an underground natural storage of water held between rocks and sediments). An outcrop is an area where the aquifer formation emerges at the Earth's surface (Figure 2). This aquifer spans parts of Botswana and South Africa, and is the most important groundwater resource for the urban and peri-urban settlements of southeast Botswana. The aquifer is vulnerable to contamination from the surface, especially in the outcrop areas where there are no overlying geological layers protecting the aquifer. Nitrate concentrations up to 29 mg L⁻¹ as nitrogen have been found in the area (Figure 3[b]). The World Health Organization (WHO) standard for drinking water is 10 mg L⁻¹ nitrate as nitrogen (or 45 mg L⁻¹ nitrate as nitrate), although new research suggests nitrate at even lower concentrations can increase the risk of some forms of cancer. The mean depth to the water table in Ramotswa is 14 m. Recharge of the aquifer occurs mainly through cracks and channels eroded into the dolomite formation constituting the aquifer, where water from the surface or holes dug into the ground, such as pit latrines, rapidly pour into the aquifer. The lack of significant soil or sediment layers means there is little to no natural filtration and purification of the recharge water. Lined pit latrines help prevent human waste from infiltrating into the aquifer. In Ramotswa, there are thousands of pit latrines (Figure 4), but it is unknown how many are lined. When a pit latrine fills, the resident can choose to build a new one (pairs of pit latrines are a common sight [Figure 4]) or pay the water utility company USD 50 to pump and empty the waste from the pit latrine, which is then taken to the sewage treatment ponds.

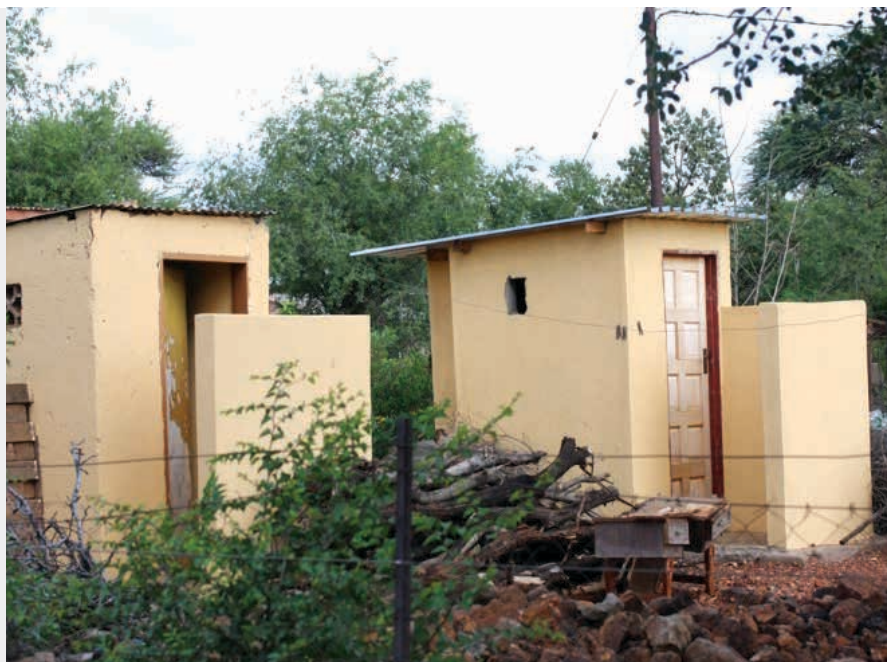
FIGURE 4. Pit latrines in Ramotswa. Pairs of pit latrines are common; as one fills up, a new one is built rather than pumping out the pit latrine that is full.
