Case for GRIPP site on Groundwater-based Natural Infrastructure

Unmanaged aquifer recharge with poor outcomes in India

Leaving untreated wastewater from the textile industry to infiltrate compromises nature-based solutions

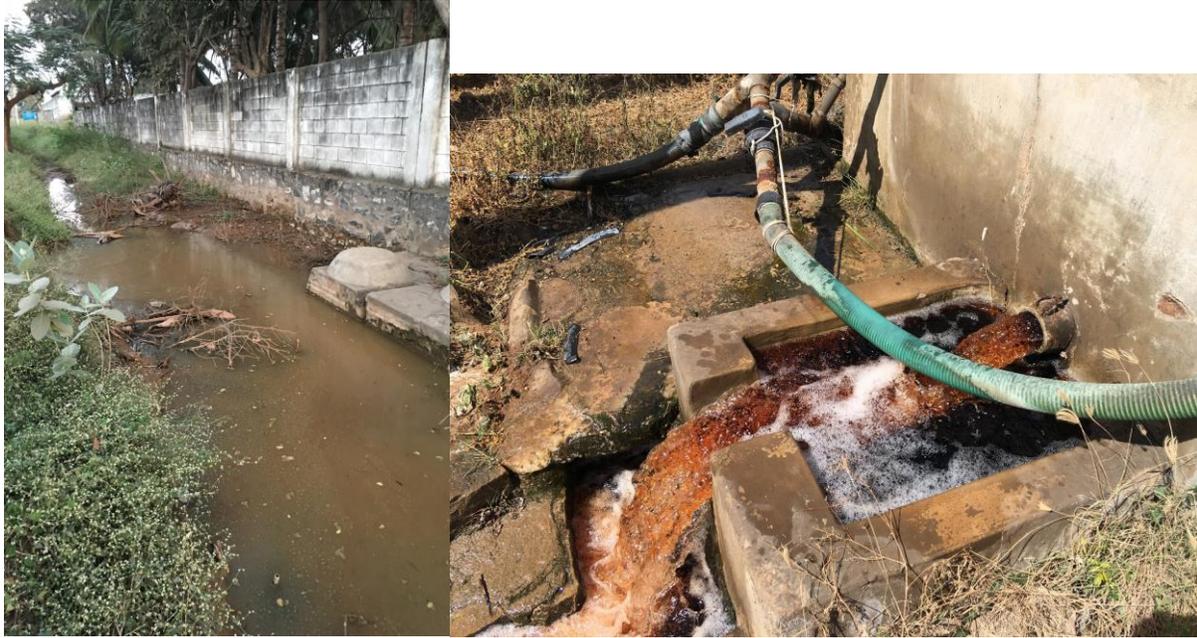
Figure 1. Left: Stagnated wastewater outside the wall of a textile dyeing factory. Right: Colored groundwater pumped from an open well just outside a state-of-the-art industrial park (photos: J. Grönwall).

The irrigation of fields with treated textile effluents is thus permissible under certain circumstances. As described here, though, various ways of emitting wastewater in a partially treated or untreated state are employed in many places in India, using intentional or unintentional approaches to groundwater-based natural infrastructure (GBNI) (Figure 1).

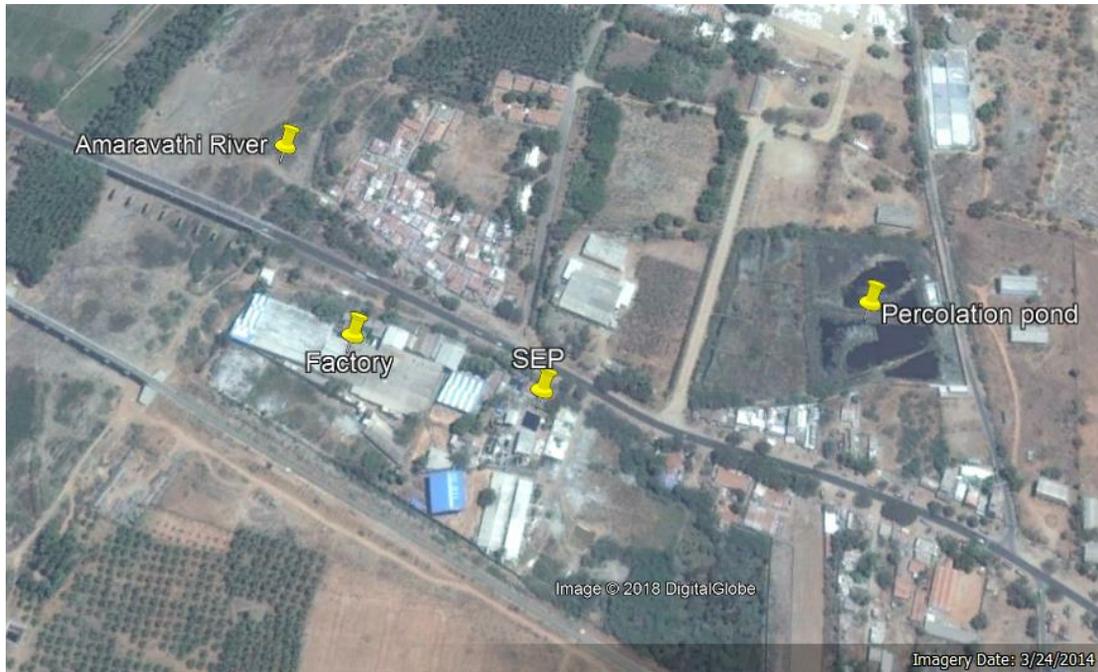
Figure 2. Google Earth historic imagery, dated March 24, 2014, illustrating the use of percolation ponds and solar evaporation pans (SEPs) during a drought period when the riverbed is dried up (photo: J. Grönwall).

The way in which percolation ponds are used to dispose of effluents is illustrated at a factory in the Tirupur region, where locals claim that large volumes of wastewater are channelled to two ponds—one next to the factory and the other about 1.5 km away. Though both are concealed

behind walls, they are visible from Google Earth satellite images. Notably, an image taken in March 2014 shows that the river was then completely dry, and all land areas suffered from drought—but the percolation ponds were filled (Figure 2).
